# Planned Improvements

## VALPARAISO CITY UTILITIES

STRATEGIC PLAN  
2ND EDITION

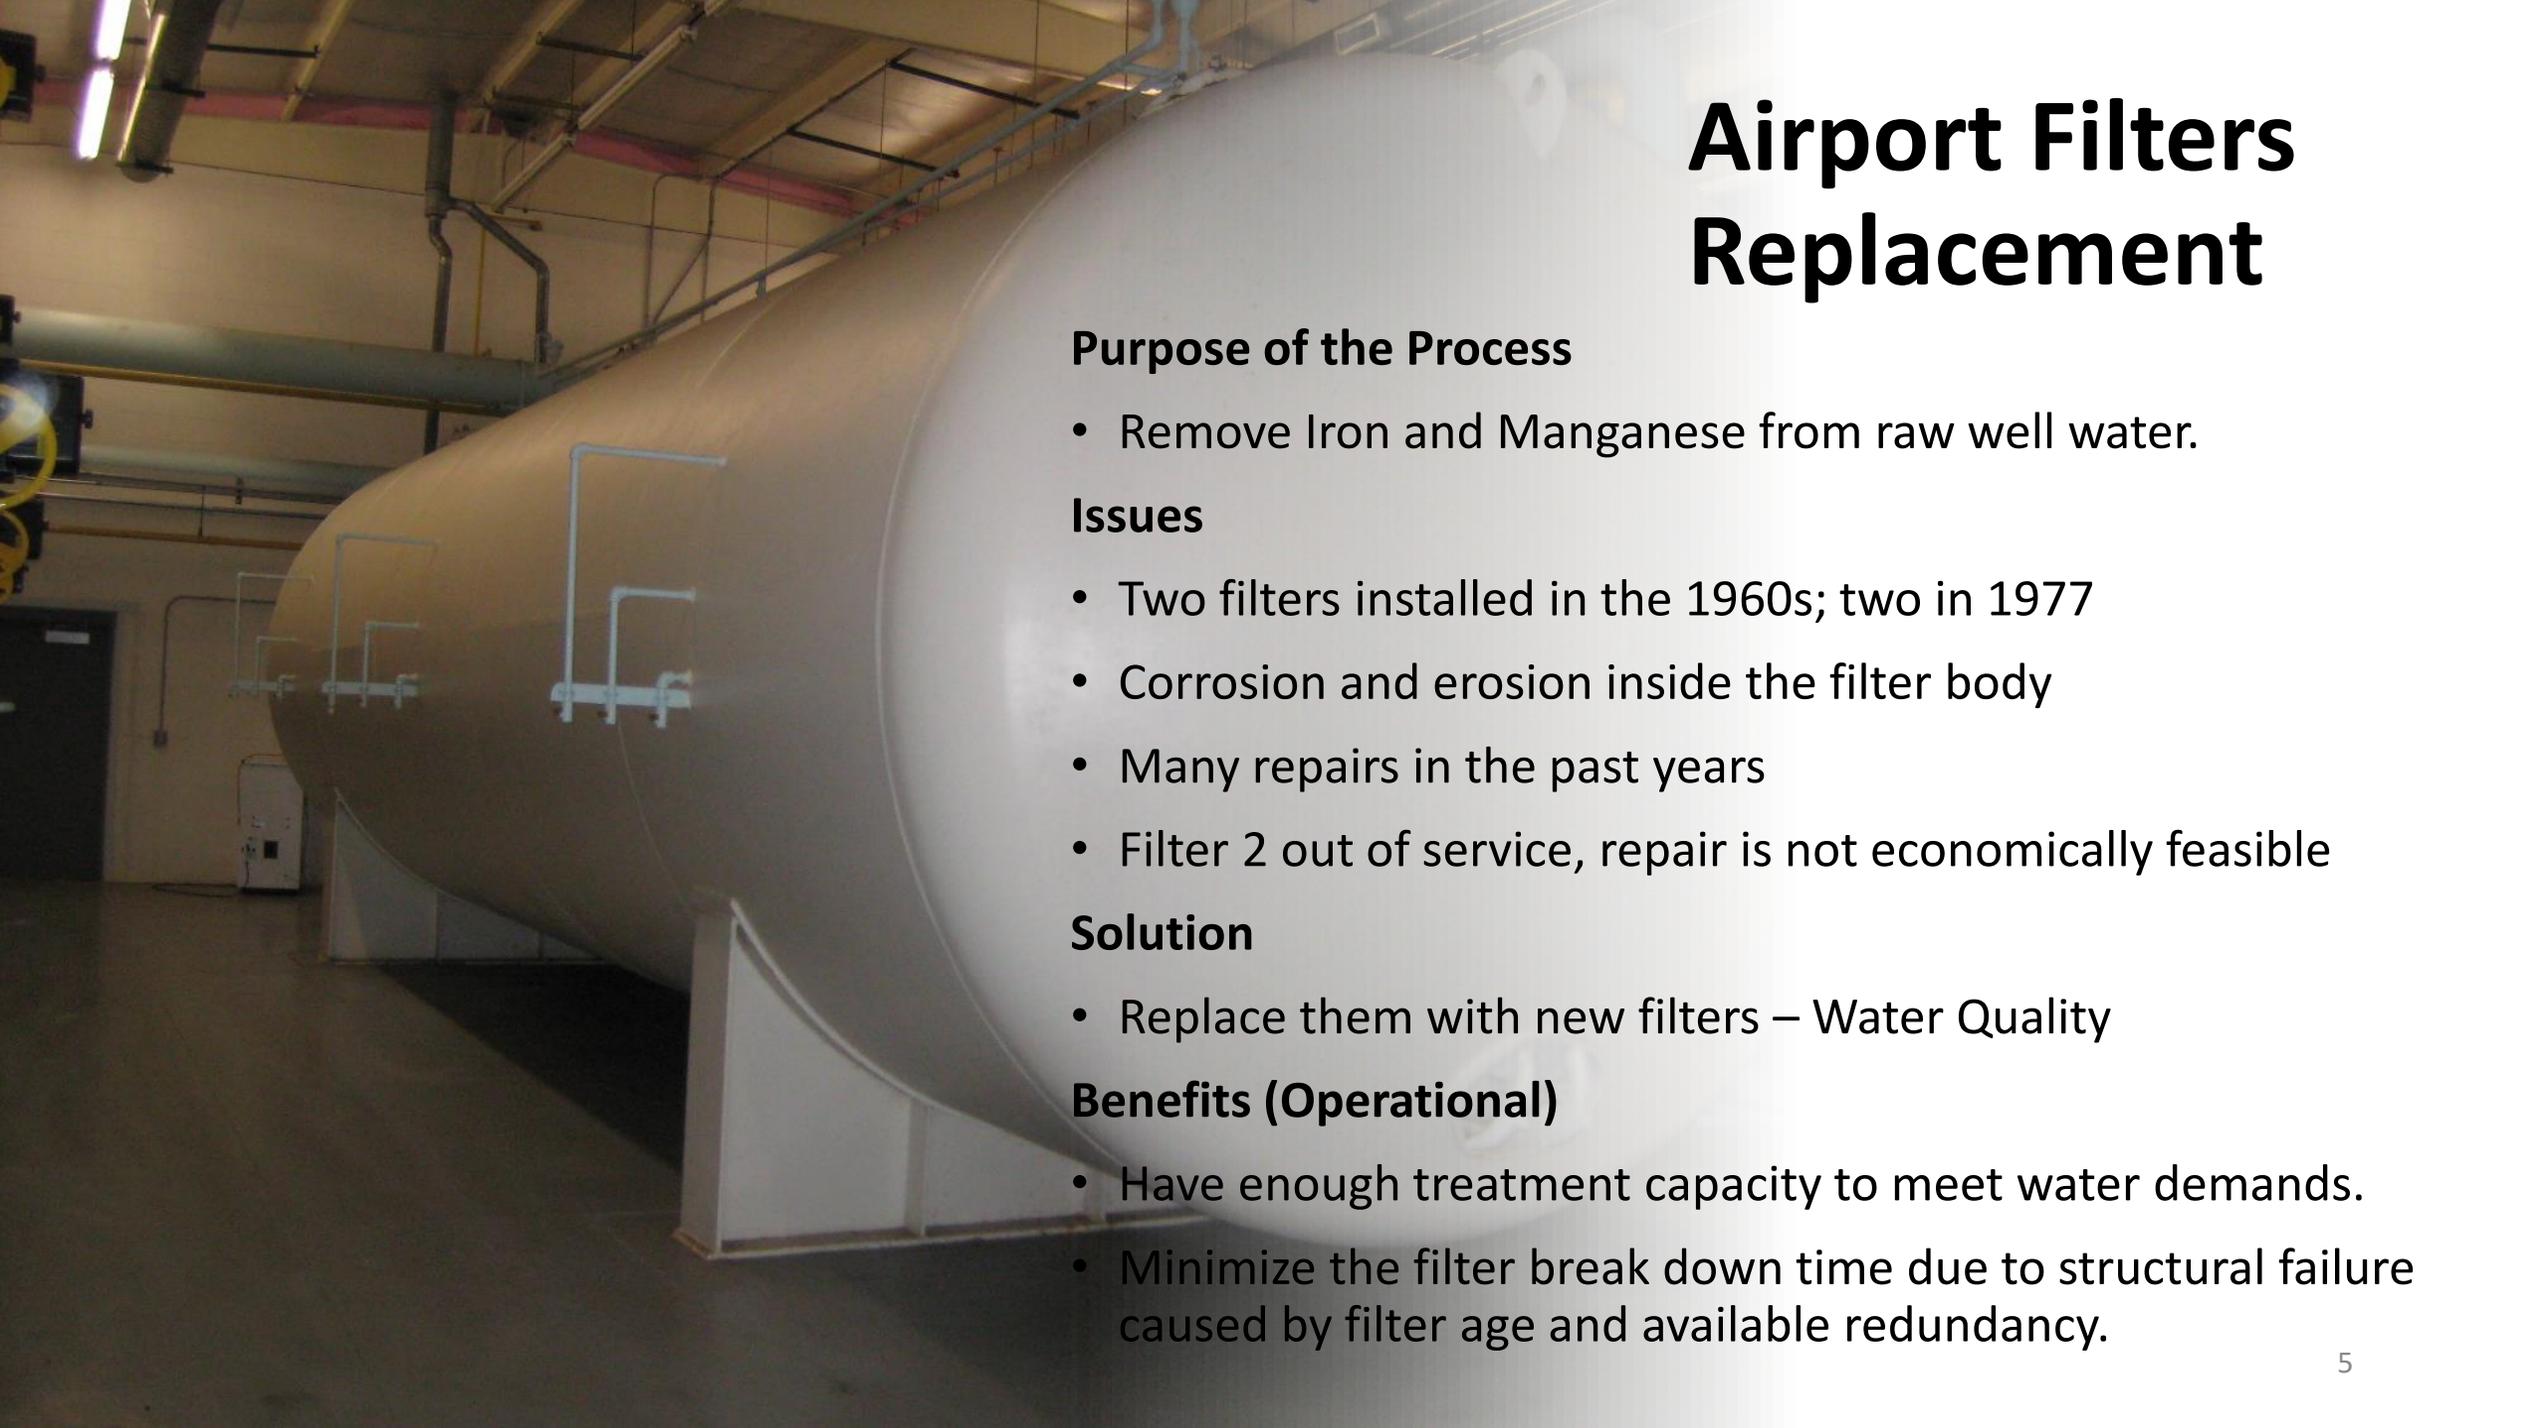
# Airport Filters Replacement

A large, cylindrical, light-colored industrial water filter tank is the central focus of the image. It is situated in a well-lit industrial facility with visible pipes, conduits, and structural elements on the ceiling and walls. The tank has several access points and valves on its side. The background shows a clean, organized industrial environment.

- Remove Iron and Manganese from raw well water.

- Two filters installed in the 1960s; two in 1977
- Corrosion and erosion inside the filter body
- Many repairs in the past years
- Filter 2 out of service, repair is not economically feasible

- Replace them with new filters – Water Quality

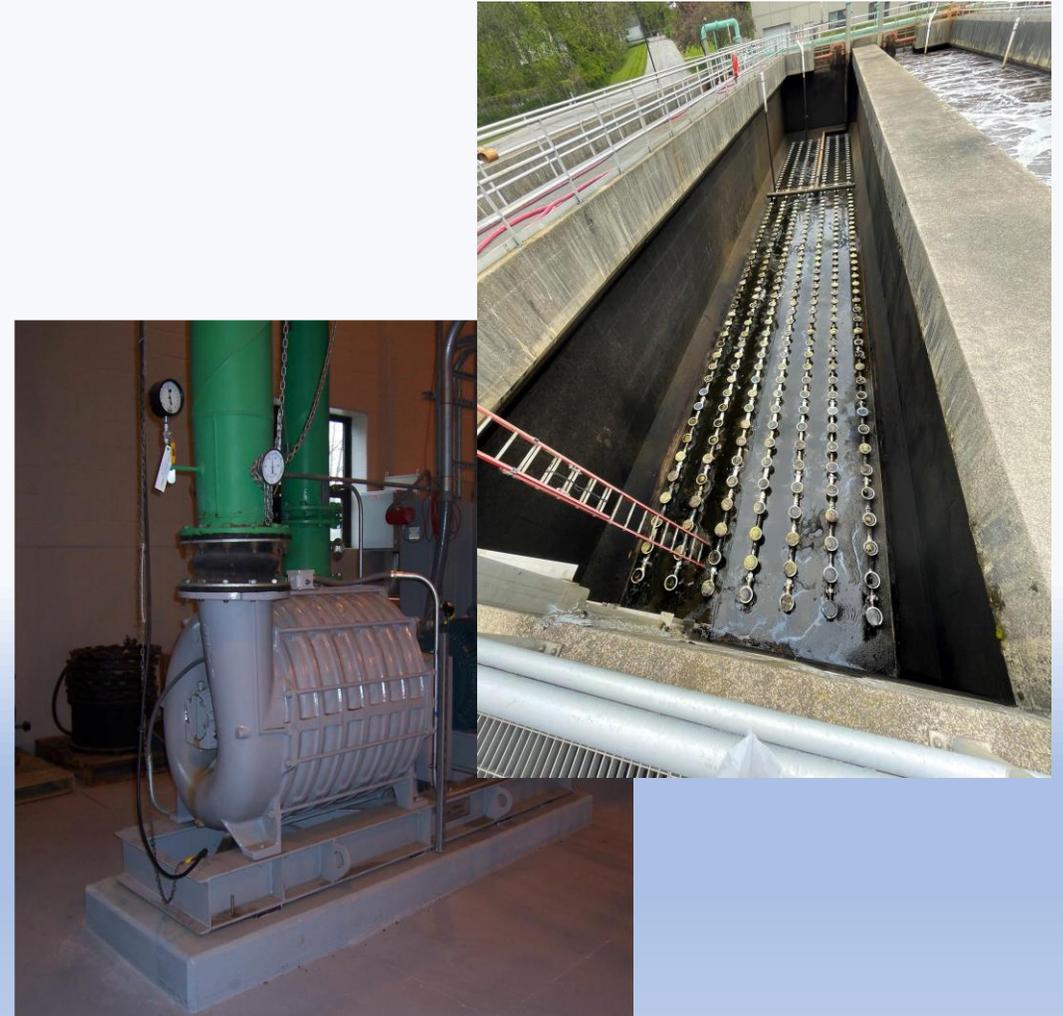
# Biological Aeration Tank Operations (Removal of Biochemical Oxygen Demand & Ammonia Nitrogen)

Existing

Modification

**Risk: Compliance with Biochemical Oxygen Demand & Ammonia Nitrogen Requirements**

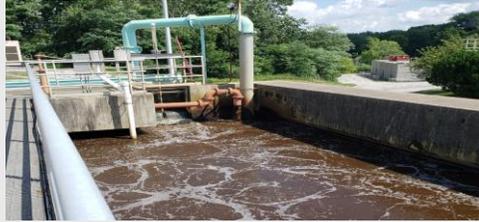
## Aeration Tanks

- 6 North ATs, 8 South ATs
- 2.74 MG Total Volume
- 5340 Total ceramic diffusers

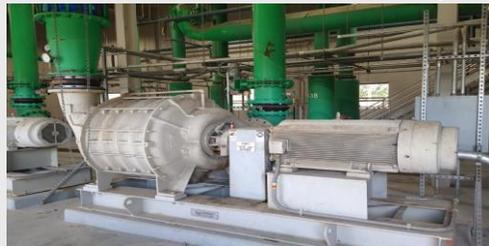
## Blower Building

- 4 Multi-Stage Centrifugal Blowers
- Two @ 8,000 SCFM (400 HP)
- Two @ 4,000 SCFM (200 HP)

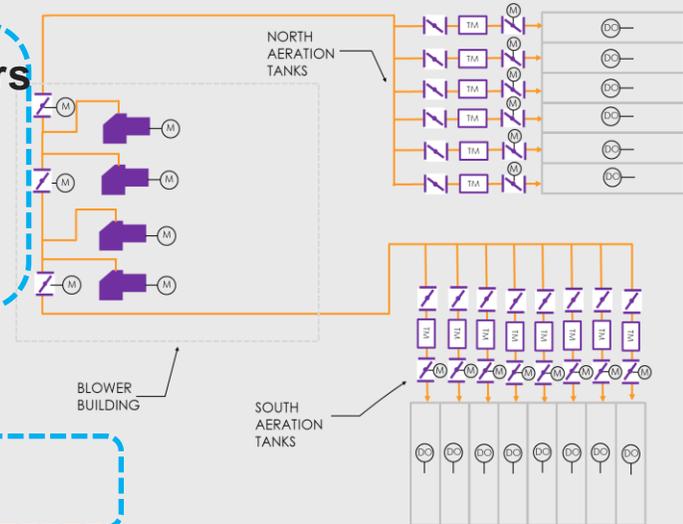
- **Membrane Diffusers**
- **2560 total**
- **New air piping**
- **Automated DO Control**

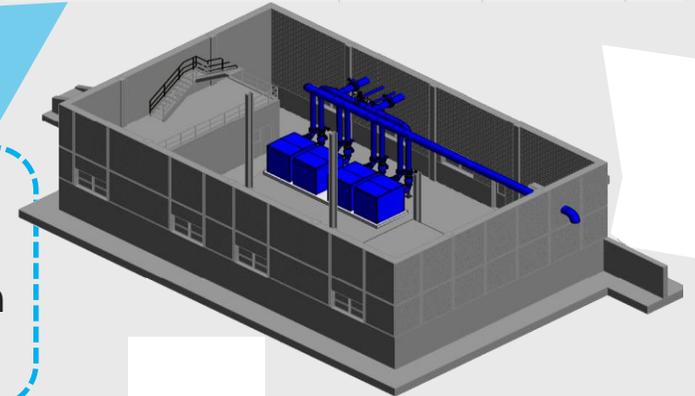
- **Hybrid Screw Blower**
- **768 SCFM Each**
- **125 HP**

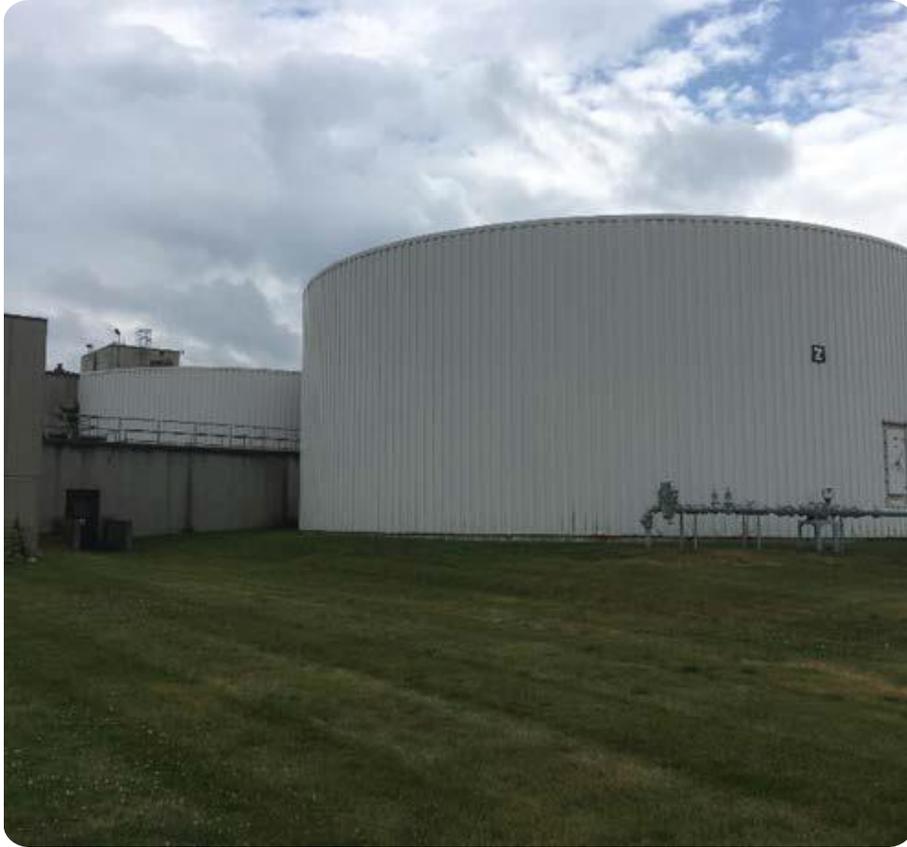
# Anerobic Digester Covers and Piping Rehab (1950s and 1970s)

- Structural covers and coatings deteriorating (1950s & 1970s).
- Gas piping and parts deteriorated, not all replacement parts available.

- Replace covers, mixing units and repair coating.
- Replace and update gas piping and associated items.

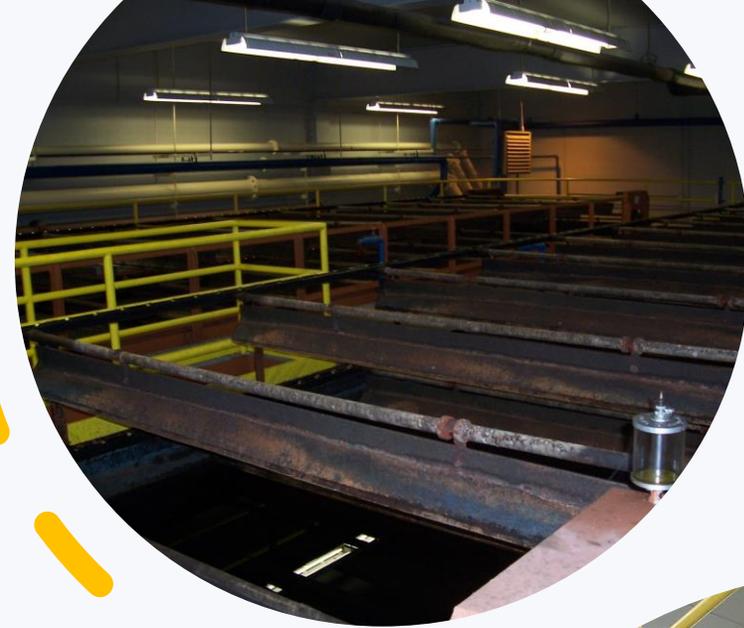
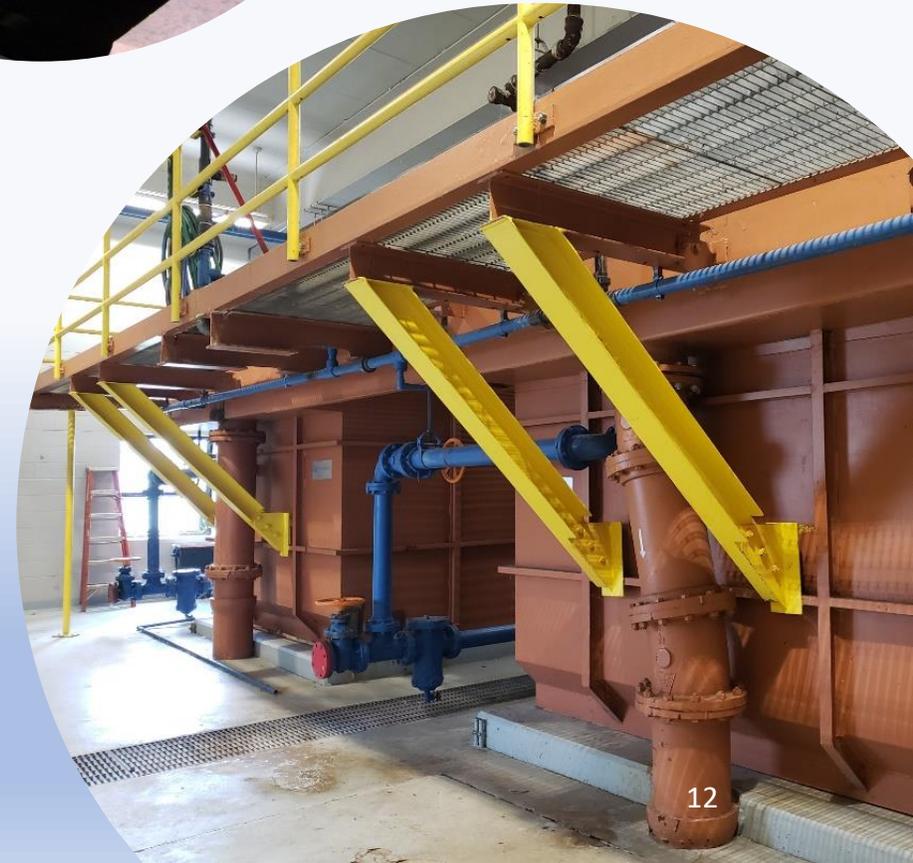
# WAS Thickening – Existing & Modifications

- Equipment installed 40+ years ago
- System lacks automation requiring frequent operator intervention
- Existing tanks are corroded

- DAF system occupies a large footprint.
- DAF system is at the end of its useful life (36 years in service).
- Unit is corroding; Sandblasting and Coating are no longer effective

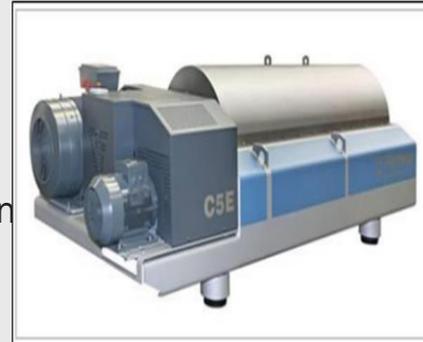
## Modification

- **Centrifuge thickening** is the recommended technology
- Design Condition
- 2 units (1 Average; 2 Max Day)
- Expected run times:
  - 4.75 hrs (Average)
  - 6.73 hrs (Max Day)
- Produce 4-6% TS solids to digestion

- **Two (2) WAS feed pumps**
- **Centrifuge package**
- **Two (2) centrifuges**
- **Two (2) thickened sludge pumps**
- **Two (2) sludge hoppers gates**
- **Associated controls and monitoring equipment**
- **Polymer delivery system**

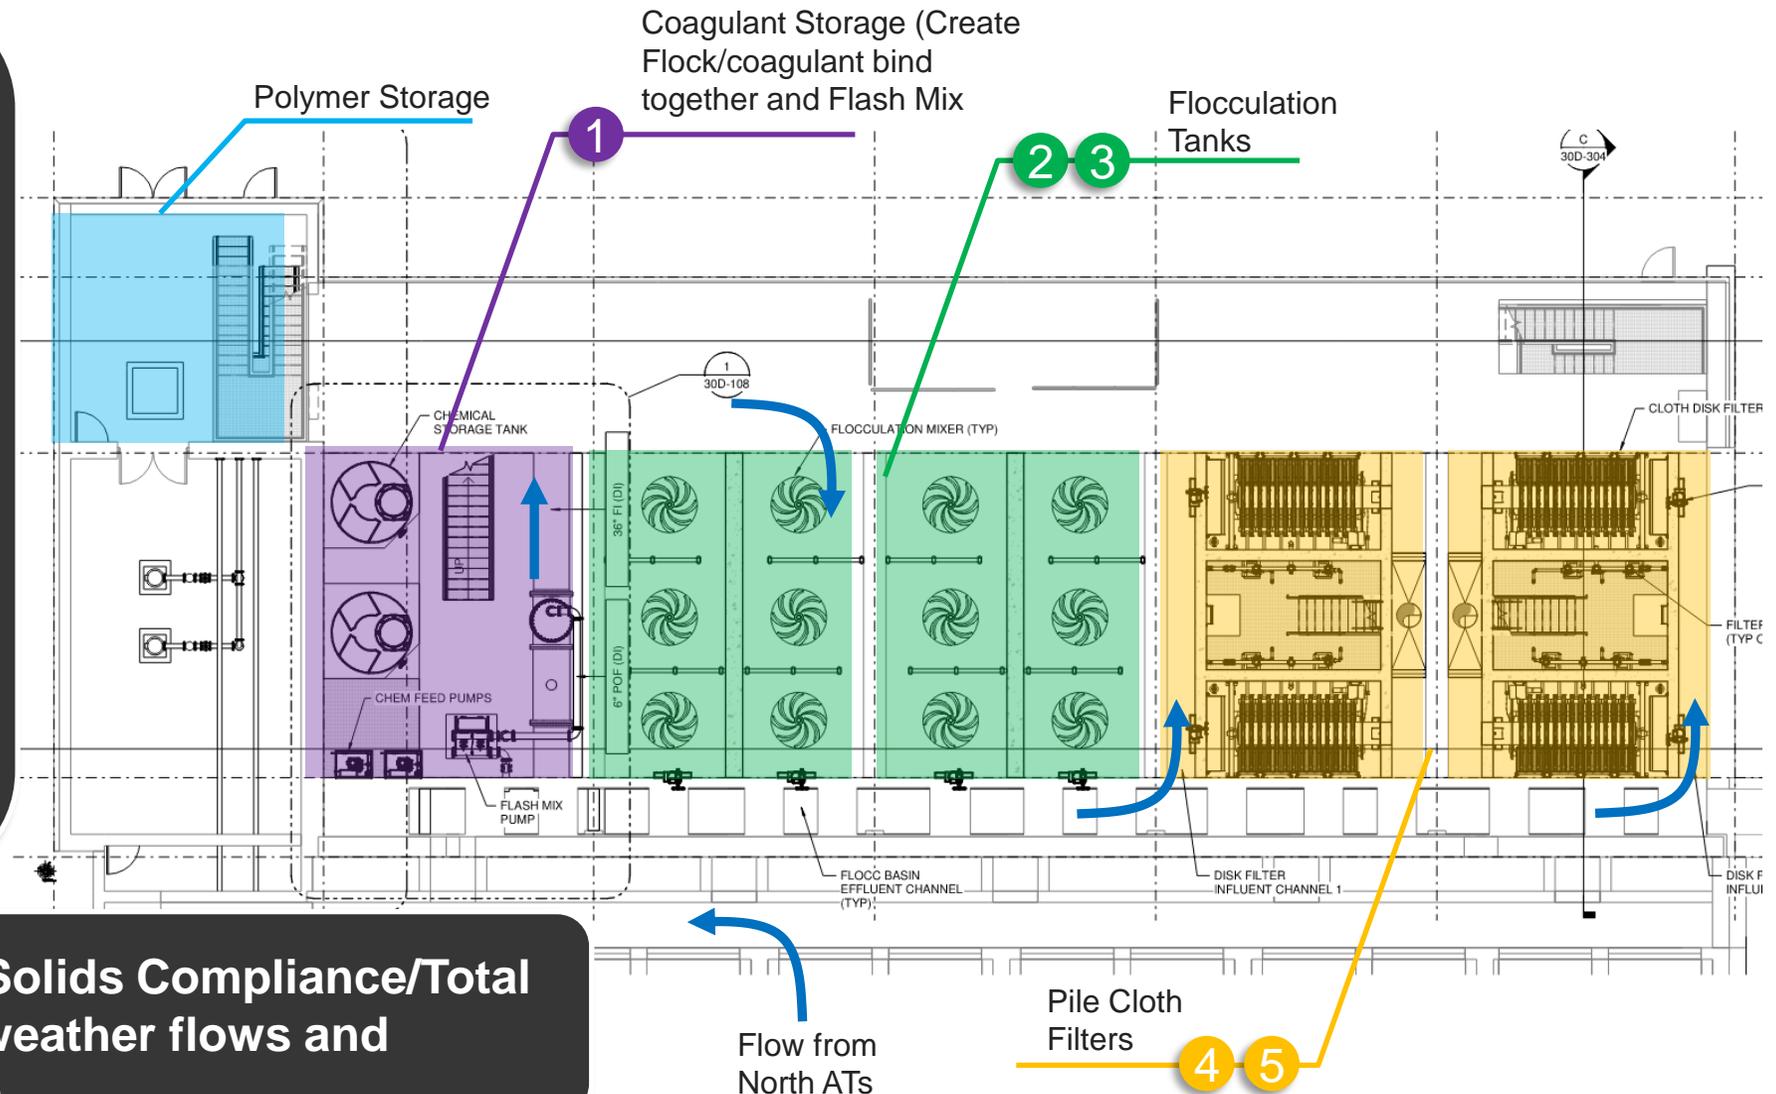
# Filter Rehabilitation Design

**Objective:** Improve filter performance with respect to Total Suspended Solids and Total Phosphorus removal and increase component capacity.

- ✓ Higher Solids & Phosphorus Removal
- ✓ Peak flow increased to 22.5 MGD from 13.5 MGD
- ✓ Less Power Used for Cleaning Cloth Filters
- ✓ Higher Treatment Capacity in Smaller Footprint
- ✓ Can expand to Future Cells within same footprint.

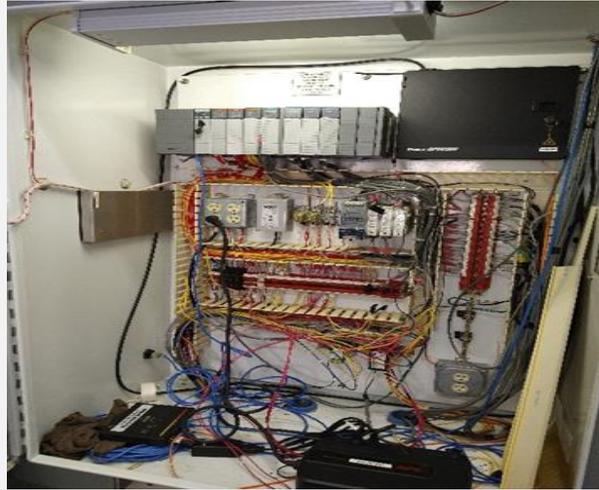
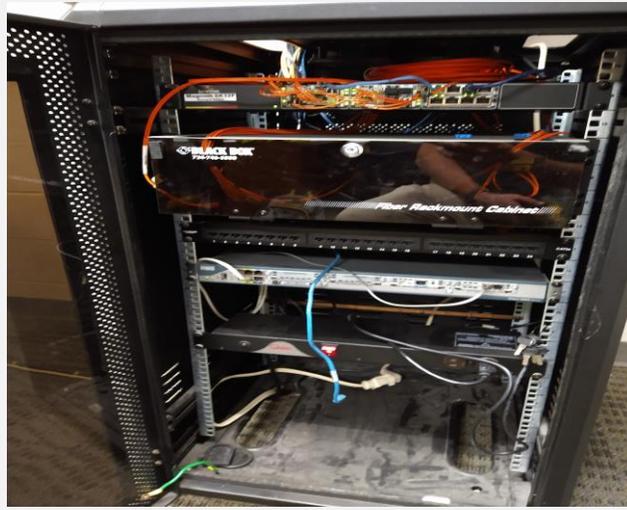
UV Building PLC

Control Building PLC

- New Process Control System redundant servers, network switches, and fiber optic loop
- New Operator computer workstations
- New Plant-wide PLC programming and software
- Upgraded iFix software (building on existing licensing) and programming
- Other new instruments and equipment; valving, flowmeters, gas detection

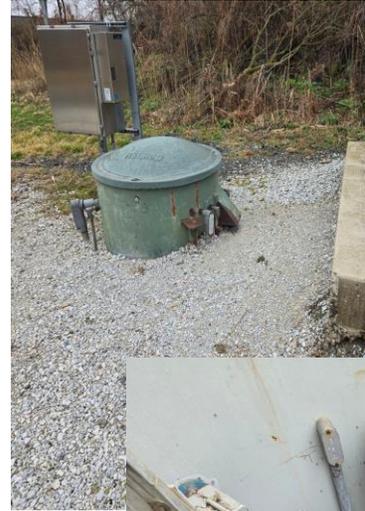
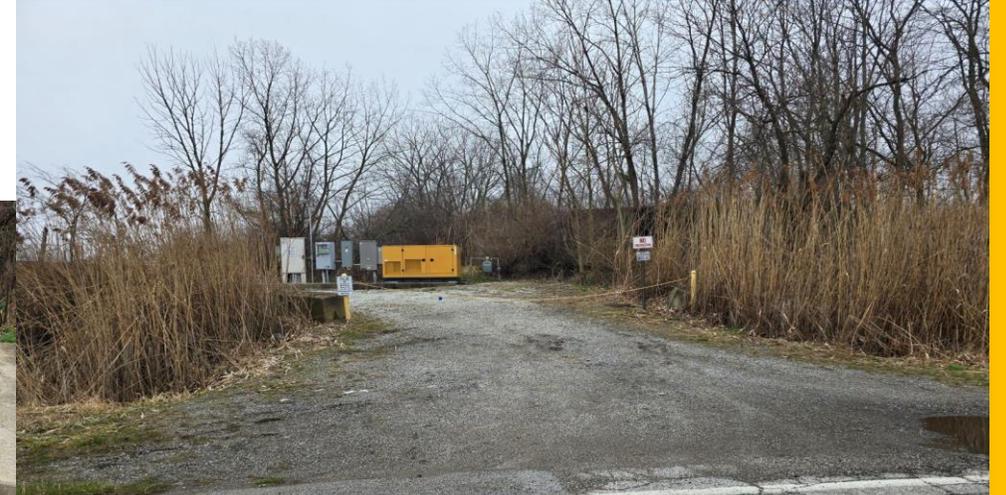
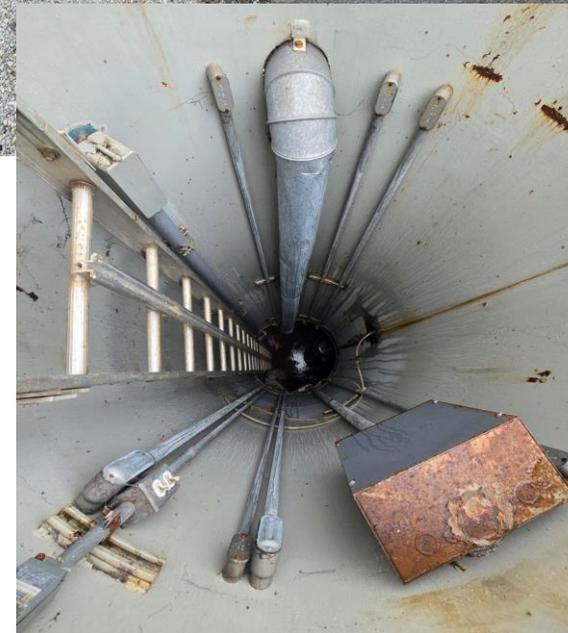
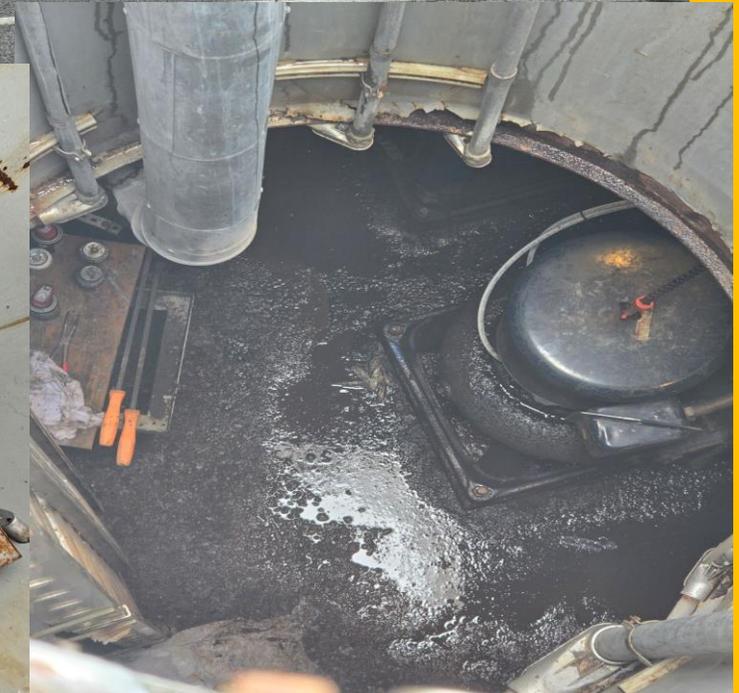
# Sturdy Road Regional Lift Station Project Constructed in the 1980s (Tin Can Design)

Useful Life Reached – 40 + Years

Force Main Failures – Piping

Limited Capacity

Pumps Plug Often

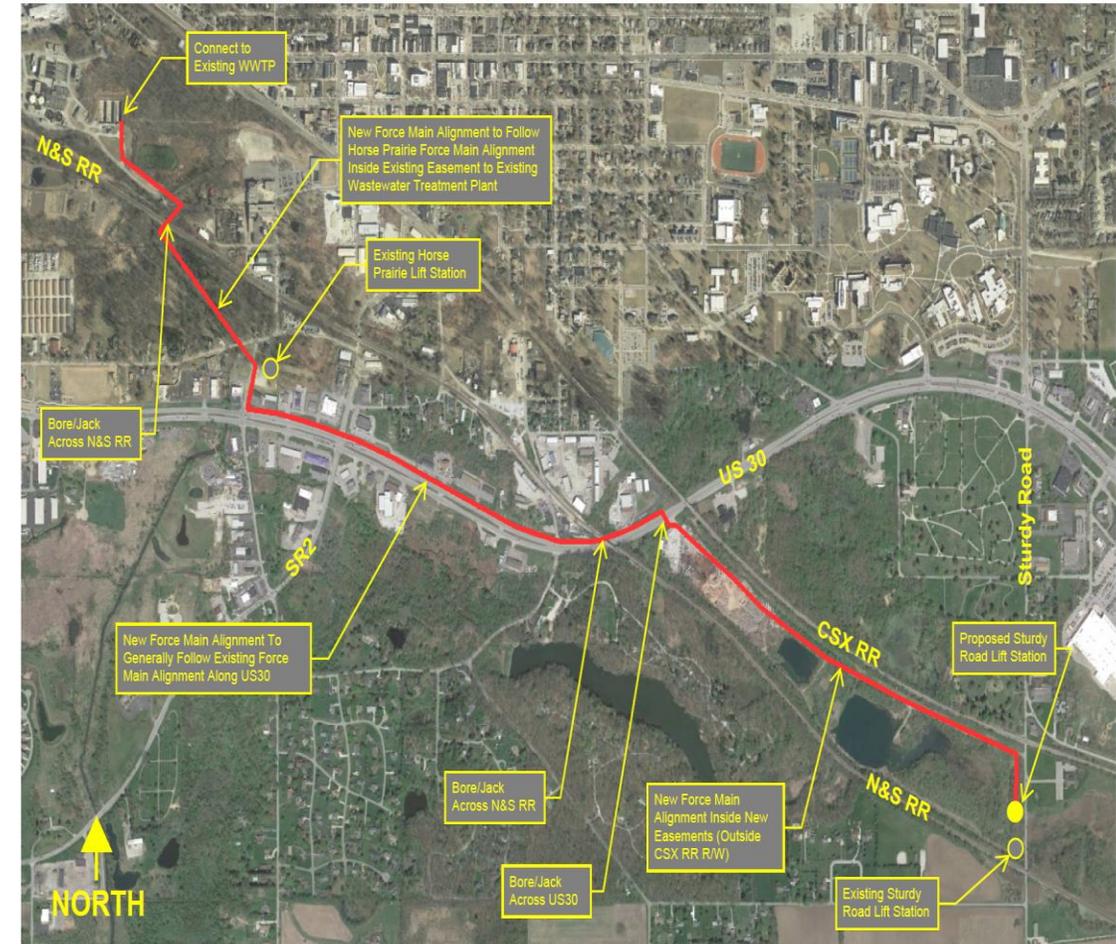
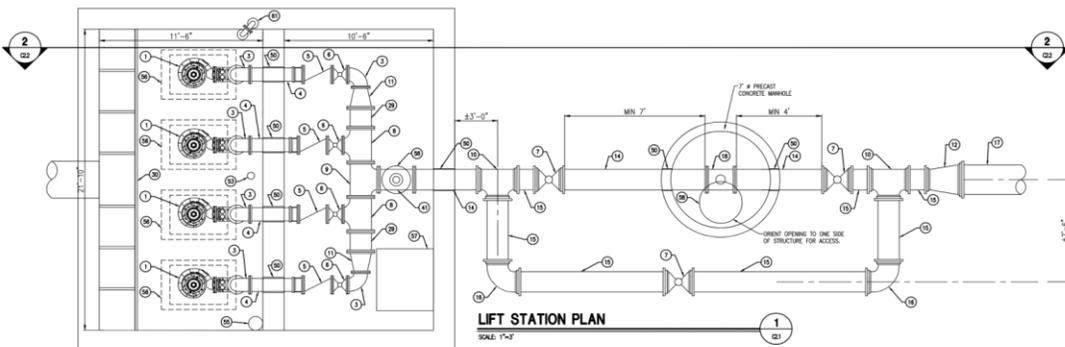
# Sturdy Road Regional Lift Station Project Upgrades

- 4 Plex Pump Station w/Redundancy Increase – Capacity to 8.2 MGD
- 13,000 Feet of C900 Plastic (Thicker diameter)
- Provide Capacity to Horseprarie Pump Station
- Employee Safety (Confined Space)
